Flood Control Project Maintenance
2018 Structure Summary Report
Overall Unit and Item Ratings

Reclamation District No. 2063 Crows Landing

Lateral No. 6 Pumping Plant

Flood Control Project Maintenance**Unit Cover Sheet****2018 Pumping Plant Inspection Results****Reclamation District No. 2063 Crows Landing**

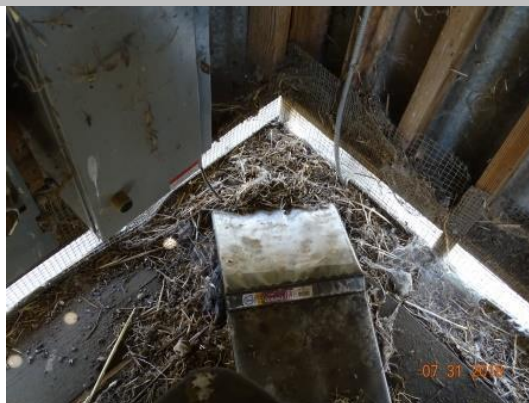
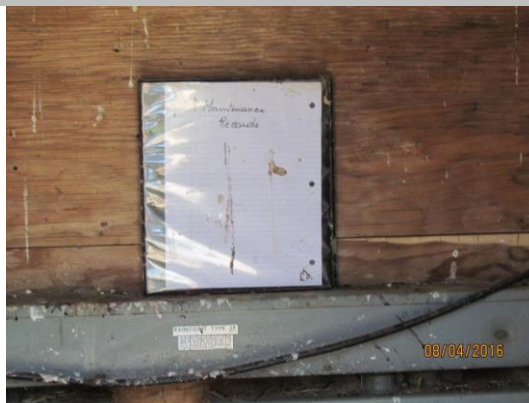
Photo 1 of 2 : ST_2018_RD2063_53_1_20180813_00014.jpg

LM Start	0.00	Rating **	A	Issue No.	1
LM End	0.00	Issue Type +	Ma	Location *	
Category	Pump Stations			GPS Latitude/Longitude	
				Start	End
Item	Operating Log			37.397931 °	37.397931 °
				-120.972176 °	-120.972176 °
DWR ID	DWR_RD2063_53_t_2012_1				
Action/Comments					
Inspector Comments: Operation log was present at the pumping plant, but needs to be replaced as it has not been protected from animal activity and is now unusable. Log should be kept in a clean and protected location within the pump house.

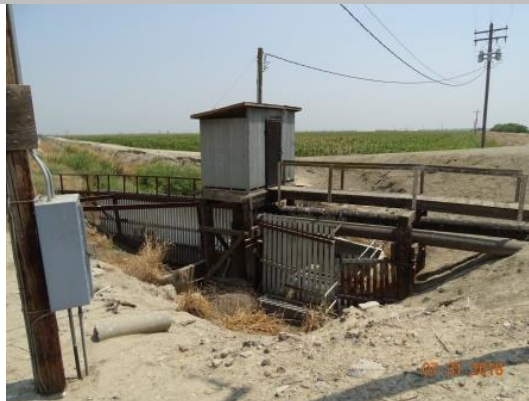
Photo 1 of 4 : ST_2018_RD2063_53_4_20180813_00015.jpg

LM Start	0.00	Rating **	M	Issue No.	4
LM End	0.00	Issue Type +	Ma	Location *	
Category	Pump Stations			GPS Latitude/Longitude	
				Start	End
Item	Plant Building			37.397931 °	37.397931 °
				-120.972176 °	-120.972176 °
DWR ID	DWR_RD2063_53_t_2012_4				
Action/Comments					
Inspector Comments: The plant building appeared to be in a good structural condition. The interior of the pump house needs to be protected from nuisance animals. Bird feces and nesting materials are strewn about and should be cleaned from the pumphouse.

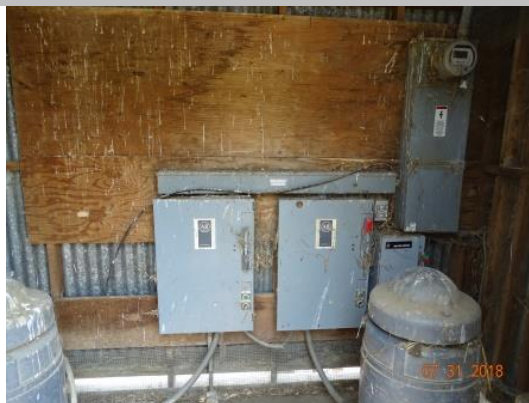
Photo 2 of 4 : ST_2018_RD2063_53_4_20180813_00016.jpg

Interior of pump house should be cleaned of debris. (2018)

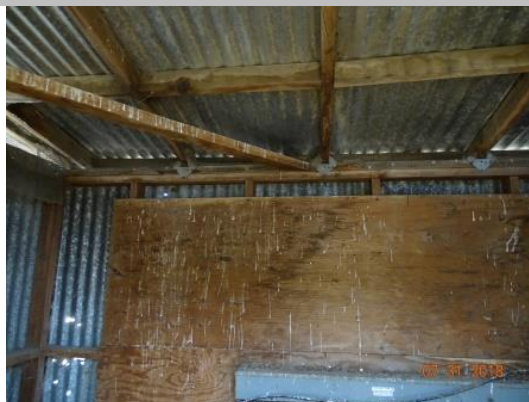
Photo 3 of 4 : ST_2018_RD2063_53_4_20180813_00018.jpg

Interior of pump house should be cleaned of debris. (2018)

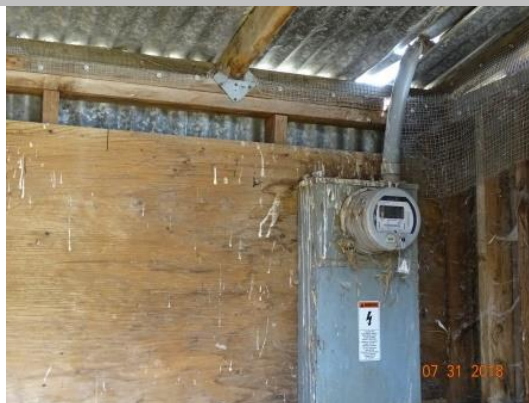
Photo 4 of 4 : ST_2018_RD2063_53_4_20180813_00019.jpg

LM Start	0.00	Rating **	M	Issue No.	4 (cont)	
LM End	0.00	Issue Type +	Ma	Location *		
Category	Pump Stations			GPS Latitude/Longitude		
				Start	End	
Item	Plant Building			37.397931 °	37.397931 °	
				-120.972176 °	-120.972176 °	
DWR ID	DWR_RD2063_53_t_2012_4					
Action/Comments						
Inspector Comments: The plant building appeared to be in a good structural condition. The interior of the pump house needs to be protected from nuisance animals. Bird feces and nesting materials are strewn about and should be cleaned from the pumphouse.

Interior of pump house should be cleaned of debris. (2018)

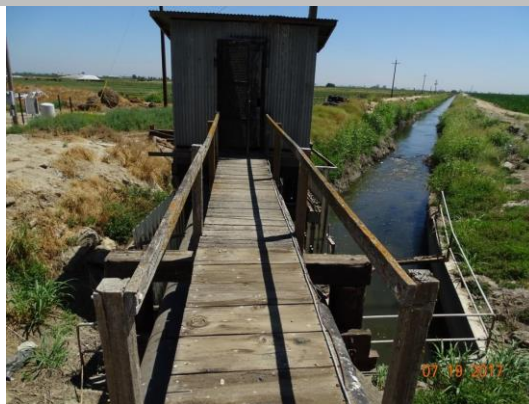
Photo 1 of 1 : ST_2018_RD2063_53_6_20180803_00003.jpg

LM Start	0.00	Rating **	M	Issue No.	6
LM End	0.00	Issue Type +	Ma	Location *	
Category	Pump Stations			GPS Latitude/Longitude	
				Start	End
Item	Safety			37.397931 °	37.397931 °
				-120.972176 °	-120.972176 °
DWR ID	DWR_RD2063_53_t_2012_6				
Action/Comments					
Inspector Comments: Right handrail leading up to pump house was unstable and may not prevent a fall if weight is applied to it.

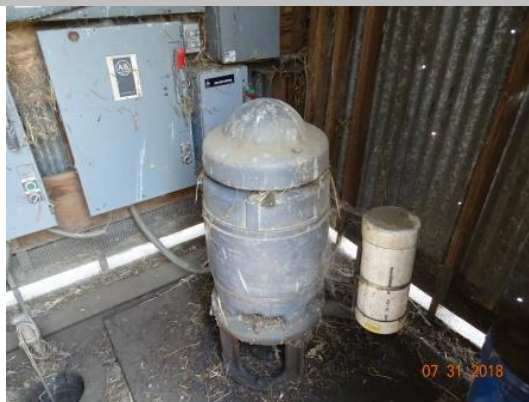
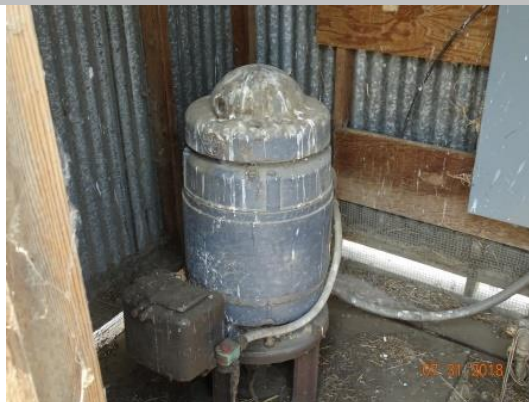
LM Start	0.00	Rating **	A	Issue No.	7
LM End	0.00	Issue Type +	Ma	Location *	
Category	Pump Stations			GPS Latitude/Longitude	
				Start	End
Item	Pumps			37.397931 °	37.397931 °
				-120.972176 °	-120.972176 °
DWR ID	DWR_RD2063_53_t_2013_7				
Action/Comments					
Inspector Comments: Pumps appeared to function, but should be protected from bird feces and nesting materials.

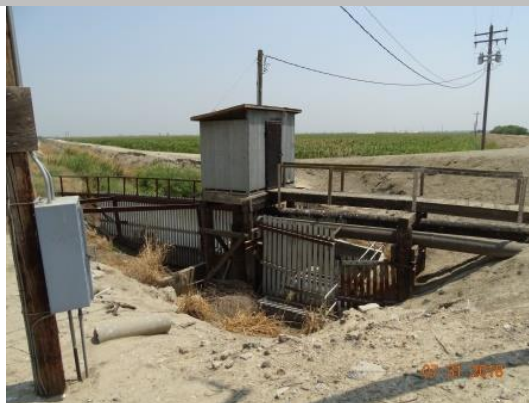
Photo 1 of 1 : ST_2018_RD2063_53_9_20180813_00022.jpg

LM Start	0.00	Rating **	A	Issue No.	9
LM End	0.00	Issue Type +	Ma	Location *	
Category	Pump Stations			GPS Latitude/Longitude	
				Start	End
Item	Power			37.397931 °	37.397931 °
				-120.972176 °	-120.972176 °
DWR ID	DWR_RD2063_53_t_2013_9				
Action/Comments					
Inspector Comments: The power source appeared to be safe and adequate.

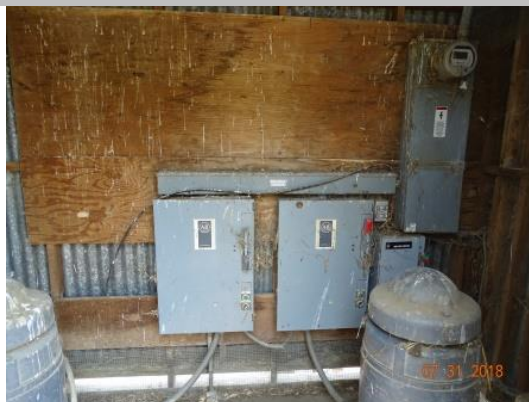
Photo 1 of 1 : ST_2018_RD2063_53_10_20180813_00023.jpg

LM Start	0.00	Rating **	M	Issue No.	10
LM End	0.00	Issue Type +	Ma	Location *	
Category	Pump Stations			GPS Latitude/Longitude	
				Start	End
Item	Pump Control Systems			37.397931 °	37.397931 °
				-120.972176 °	-120.972176 °
DWR ID	DWR_RD2063_53_t_2012_10				
Action/Comments					
Inspector Comments: Pump control systems were operational, but feces and nesting material should be removed to prevent a fire hazard.

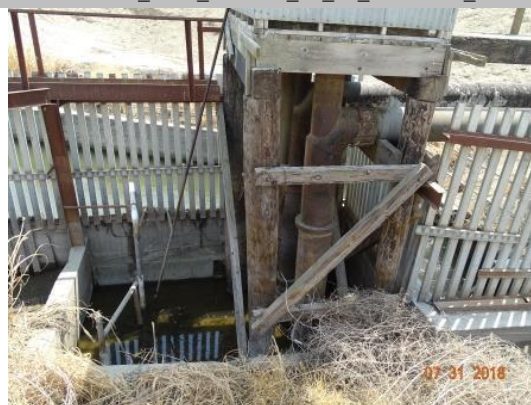
Photo 1 of 1 : ST_2018_RD2063_53_12_20180813_00025.jpg

LM Start	0.00	Rating **	A	Issue No.	12
LM End	0.00	Issue Type +	Ma	Location *	
Category	Pump Stations			GPS Latitude/Longitude	
				Start	End
Item	Sumps/Wet Well			37.397931 °	37.397931 °
				-120.972176 °	-120.972176 °
DWR ID	DWR_RD2063_53_t_2012_12				
Action/Comments					
Inspector Comments: The sump well was free of debris.

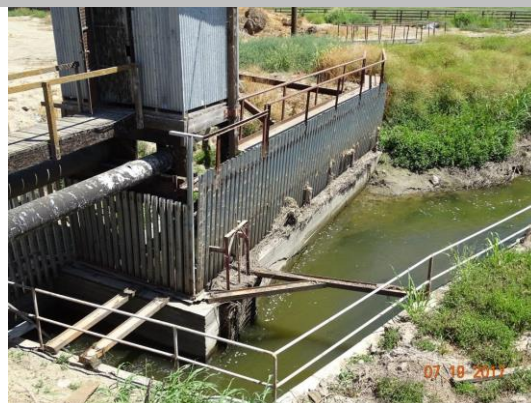
Photo 1 of 1 : ST_2018_RD2063_53_13_20180803_00010.jpg

LM Start	0.00	Rating **	A	Issue No.	13
LM End	0.00	Issue Type +	Ma	Location *	
Category	Pump Stations			GPS Latitude/Longitude	
				Start	End
Item	Trash Racks			37.397931 °	37.397931 °
				-120.972176 °	-120.972176 °
DWR ID	DWR_RD2063_53_t_2012_13				
Action/Comments					
Inspector Comments: The trash racks appears to be in good working condition.

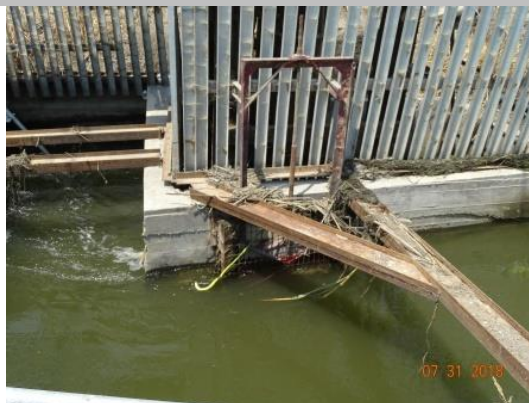
Photo 1 of 1 : ST_2018_RD2063_53_11_20180813_00024.jpg

LM Start	0.00	Rating **	A	Issue No.	11
LM End	0.00	Issue Type +	Ma	Location *	
Category	Pump Stations			GPS Latitude/Longitude	
				Start	End
Item	Sluice / Slide Gates			37.397931 °	37.397931 °
				-120.972176 °	-120.972176 °
DWR ID	DWR_RD2063_53_t_2012_11				
Action/Comments					
Inspector Comments: The slide gate appeared to be in working condition.

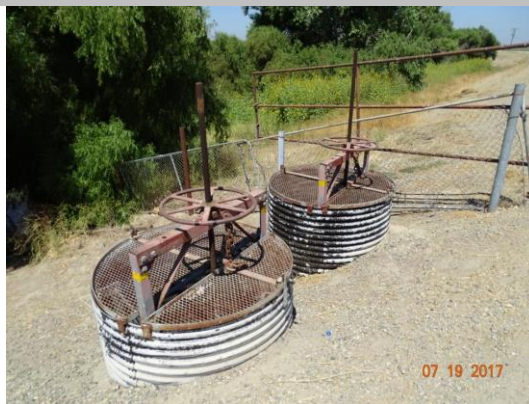
Photo 1 of 1 : ST_2018_RD2063_53_17_20180803_00012.jpg

LM Start	0.00	Rating **	A	Issue No.	17
LM End	0.00	Issue Type +	Ma	Location *	
Category	Pump Stations			GPS Latitude/Longitude	
				Start	End
Item	Manual Gate Operators			37.397931 °	37.397931 °
				-120.972176 °	-120.972176 °
DWR ID	DWR_RD2063_53_t_2012_17				
Action/Comments					
Inspector Comments: The manual gate operator appeared to be in working condition.

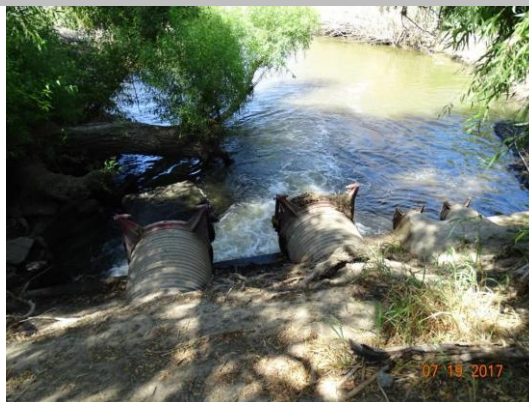
Photo 1 of 1 : ST_2018_RD2063_53_16_20180803_00011.jpg

LM Start	0.00	Rating **	A	Issue No.	16
LM End	0.00	Issue Type +	Ma	Location *	
Category	Pump Stations			GPS Latitude/Longitude	
				Start	End
Item	Flap Gates			37.397931 °	37.397931 °
				-120.972176 °	-120.972176 °
DWR ID	DWR_RD2063_53_t_2013_16				
Action/Comments					
Inspector Comments: Flap gates appeared to be in a good working condition.

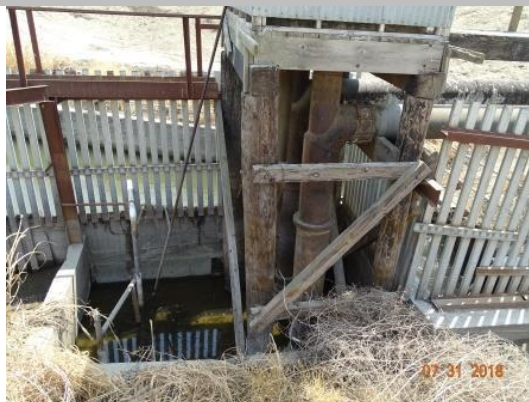
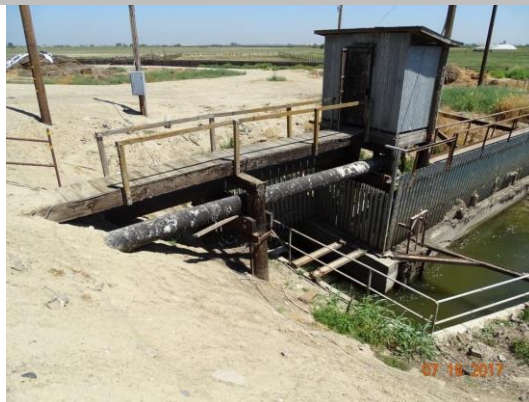
LM Start	0.00	Rating **	A	Issue No.	20
LM End	0.00	Issue Type +	Ma	Location *	
Category	Pump Stations			GPS Latitude/Longitude	
				Start	End
Item	Intake and Discharge Pipes			37.397931 °	37.397931 °
				-120.972176 °	-120.972176 °
DWR ID	DWR_RD2063_53_t_2013_20				
Action/Comments					
Inspector Comments: The intake and discharge pipes appeared to be in good condition.
